Estates and Facilities Alert

Ref: EFA/2013/004

Cold water storage tanks

The use of uncapped PVC-U pipes (or similar) within cold water tanks as a support structure for the lid is likely to lead to stagnation and harbouring of harmful micro-organisms.

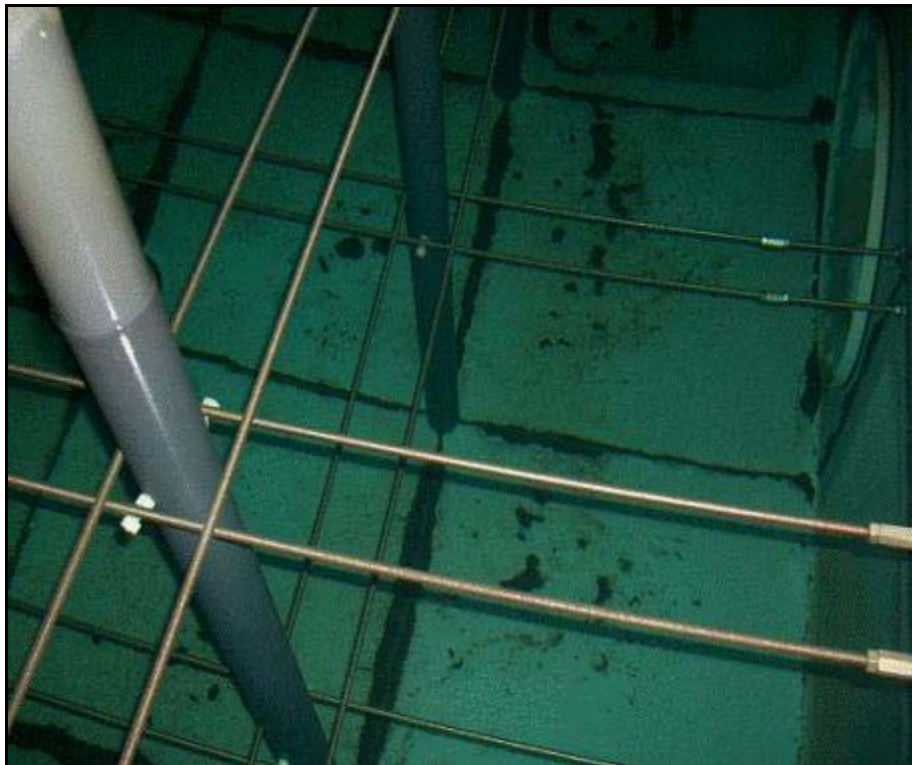
Photo 1

2. Construction of the tanks utilised vertical 4 inch PVC-U pipes to support the lid, held in position by strategically placed cross-members (see Appendix, Photo 1), a permanent tank design adopted by at least three manufacturers.

3. The pipes were saw-cut to length with the top supporting the lid and the base sitting directly on the tank floor. Since the ends of the pipes were not sealed, water was able to seep into and out of the pipes as the tank water level varied, providing near stagnant conditions for micro-organism growth while at the same time preventing effective disinfection. When the tank was drained and a pipe dislodged, detritus spilled out, further supporting the conclusion that this was almost certainly the source of the contamination.

Cold water storage tank interior as constructed
(uncapped vertical PVC-U pipe held in position by cross members)

5. Inspect water tanks for uncapped and semi-submersed hollow pipes (or similar) used as a support structure. These should be removed to eliminate possible contamination and replaced with 'clean' solid supports, i.e. ones without cavities, crevices or details allowing water to stagnate and harbour micro-organisms.
6. Tank manufacturers and installers who employ hollow pipe supports in their cold water tanks should be alerted to the issues highlighted in this alert.

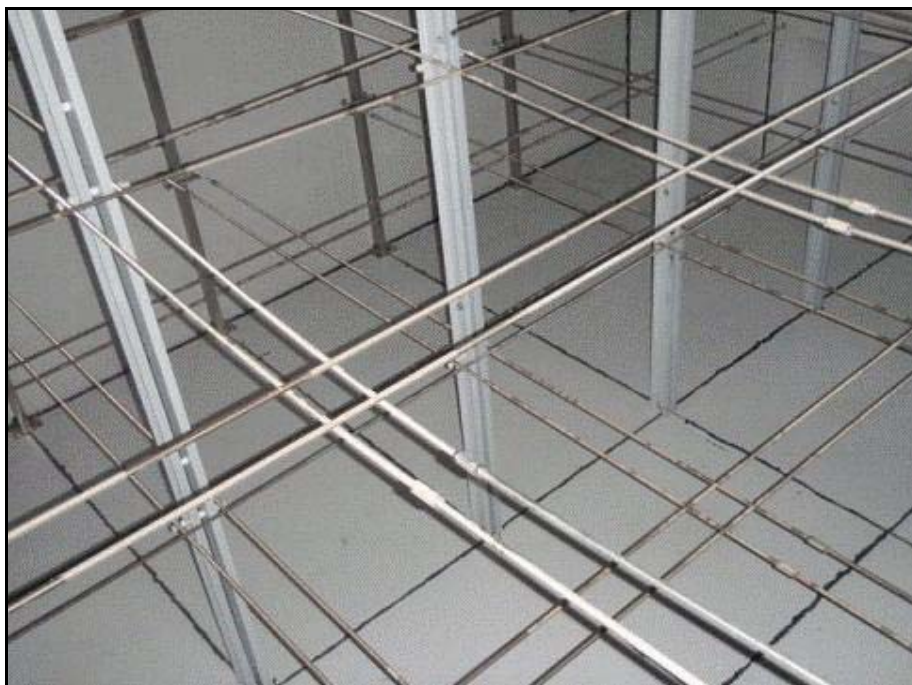
Photo 2

Cold water storage tank as altered
(solid vertical lid supports)

4. Replacing the pipes with solid supports proved successful in eliminating the source of contamination (see Appendix, Photo 2).
